## Slot harmonics in power generation systems

In this article we will look at slot harmonics, and a case study of resonance with these types of harmonics that are generated.

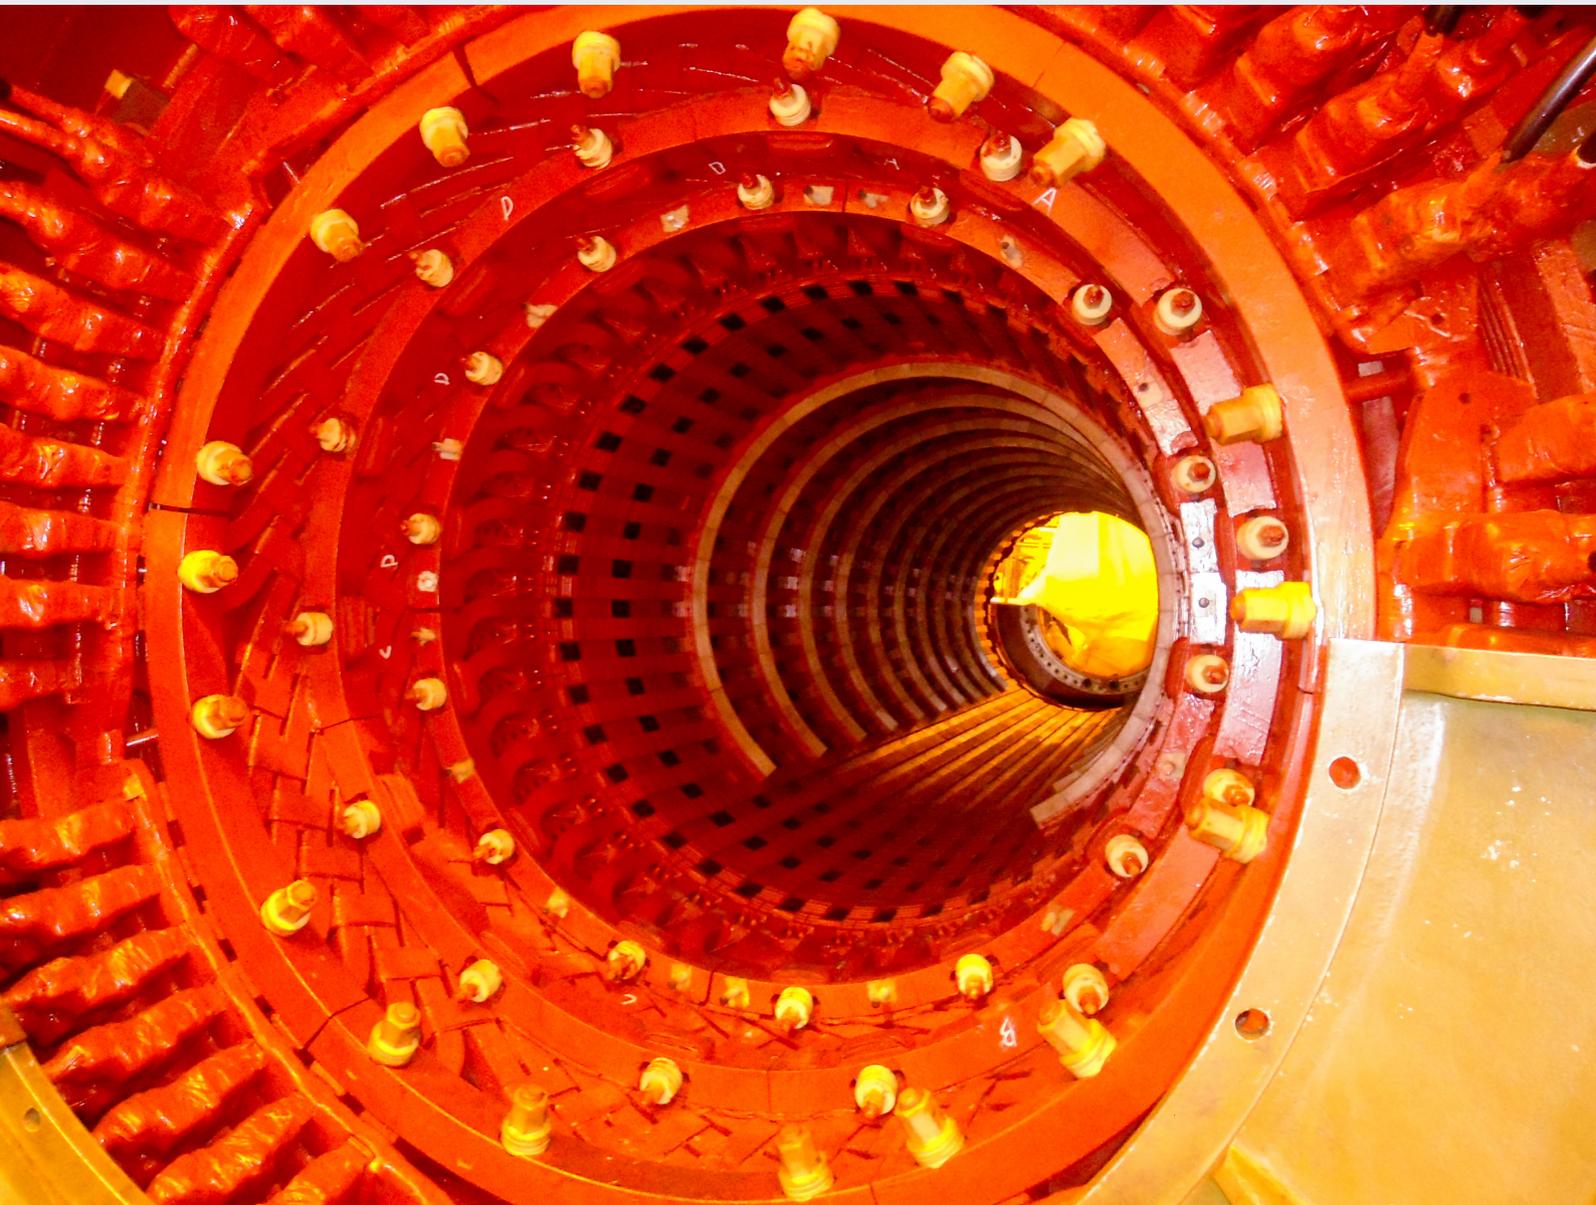
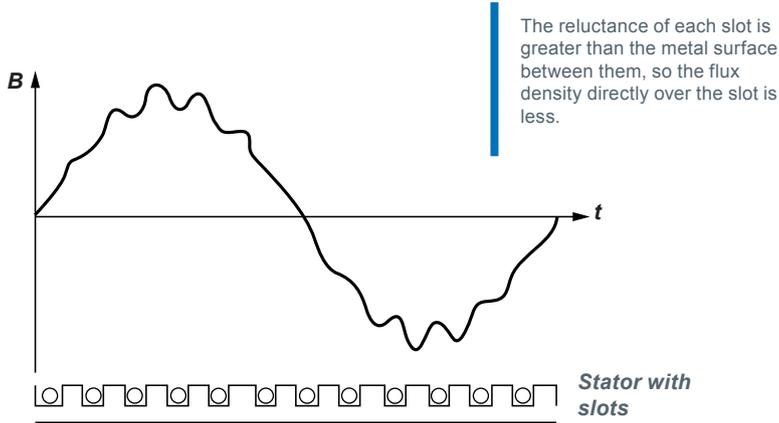
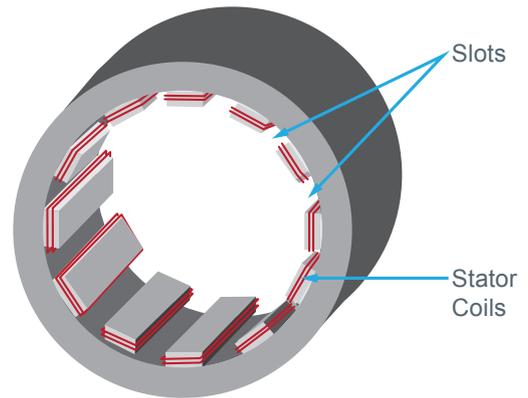
Induction Motor Elements.  
The existence of uniform slots around the internal part of the stator causes regular variations of reluctance and flux.

The actual construction of the stator windings of alternating current rotating electric machines can give rise to the appearance of harmonic components in voltage known as “slot harmonics”.

The existence of uniform slots around the internal part of the stator causes regular variations of reluctance and flux over the stator surface, producing distortion of the voltage wave.

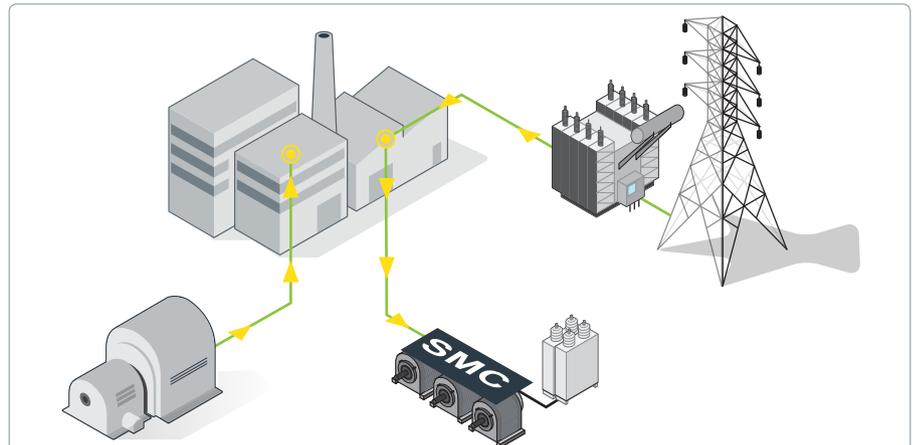
Simplified diagram of the electrical system and electrical measurements

In this case the industry in question has a dual power supply, consisting of a 6.5 MW, 4.16 kV/60 Hz generator and direct power supply from the electrical network through a 69 kV primary

electrical network with a 9 MVA transformer and 4.16 kV/60 Hz secondary. The installation had a motor control system (SMC), which was compensated with a 50 kvar, 4.16 kV capacitor.

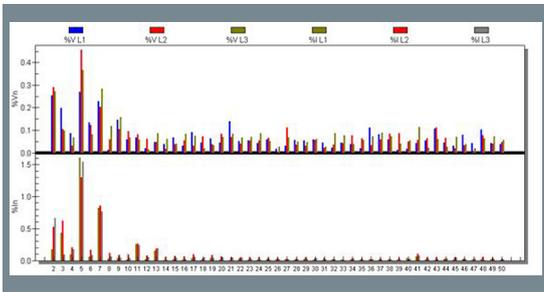
Fig.1

Table 1 summarises the main electrical parameters measured, showing that the variation of the harmonic components

without (Fig. 1 and 2) or with (Fig. 3 and 4) a capacitor bank is practically the same, having at all times the correct levels.

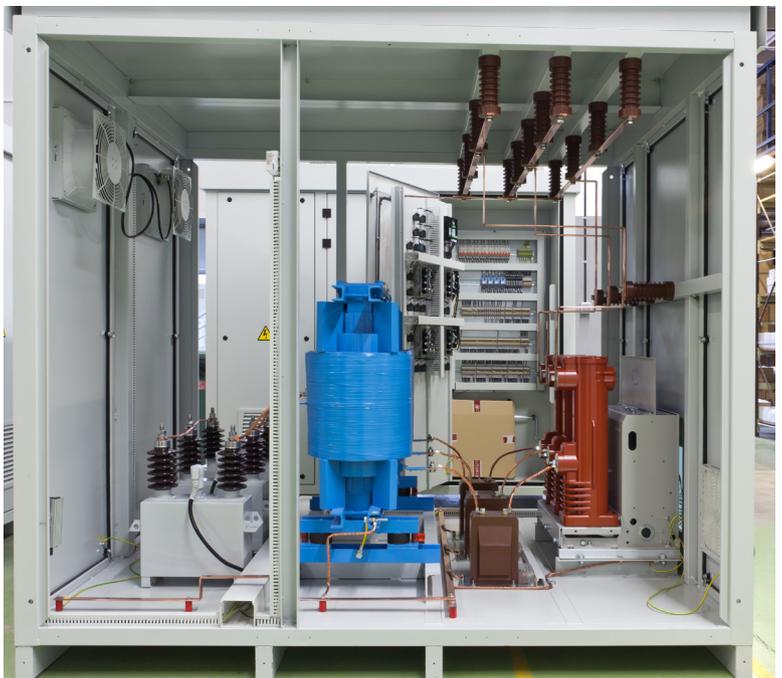
Table 2 shows the performance of the system powered by the 6.5 MW generator. There is a considerable increase in the voltage distortion when

the 50 kvar capacitor is connected; the increase is mainly produced in the 37th order harmonic.

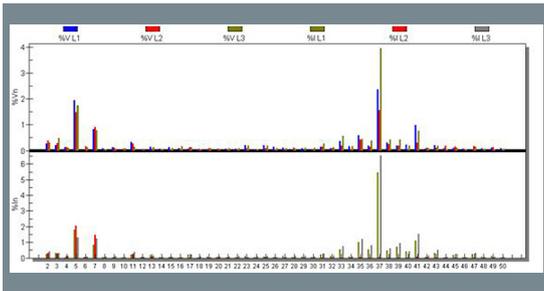
Fig.5

As figures 6 and 7 without a capacitor and figures 5 and 8 with a capacity show, the harmonic distortion operating with the generator is greater compared to the distortion produced operating directly with the electrical network; the 5th and 37th order components have apparently negligible amplitudes (1.89% and 1.26% respectively).

With the capacitor bank operating, there is resonance in the 37th harmonic with its amplitude at high values (>3%). There were failures during the test, including the false alarm in the boiler control because of voltage distortion in all the circuits powered by the generator.

In this case, the immediate measure was to leave the 50 kVAR capacitor permanently out of service, and to consider the need to use a capacitor bank with a detuned filter, detuned to 7%. However, the presence of the 37th voltage harmonic, being a generator design flaw, cannot be eliminated, meaning that in low load periods the same false alarm was produced in the boiler control. It was therefore suggested that power should be provided through an online type UPS system in order to eliminate this component from the power supply voltage.

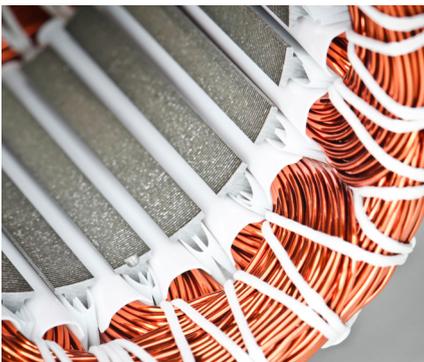
Fig.9

$$v_{slot} = \frac{2 \cdot M \cdot S}{P} \pm 1 = \frac{2 \cdot 1 \cdot 72}{4} \pm 1 = 35 \text{ and } 37$$

We also saw that the generator was 4-pole and had 72 slots in its stator, so by applying the initial formula its lowest order slot harmonics are 35 and 37, coinciding with the resonance produced in the installation, and which entailed the various underlying problems. (Fig. 9)

An interesting aspect of this test was the fact that as the load dropped to 0, the distortion of the voltage wave increased, as shown in the figure with the profile of the voltage distortion rate THD(U)%.

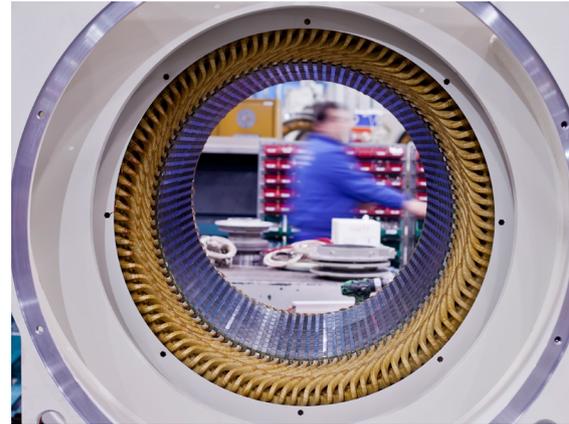
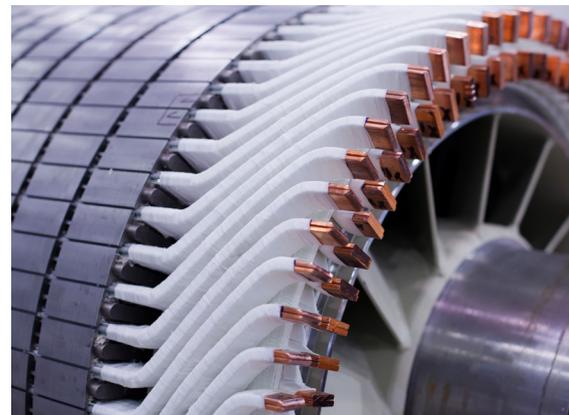
**Detail of the rotor and the stator in a generator.**

Normally in both the stator and the rotor the electrical system consists of copper conductor windings through which currents are supplied or transferred to an external circuit flow.
